Proposed re-route Phleger West Union Creek

Mike Bushue
ETRAC

110724

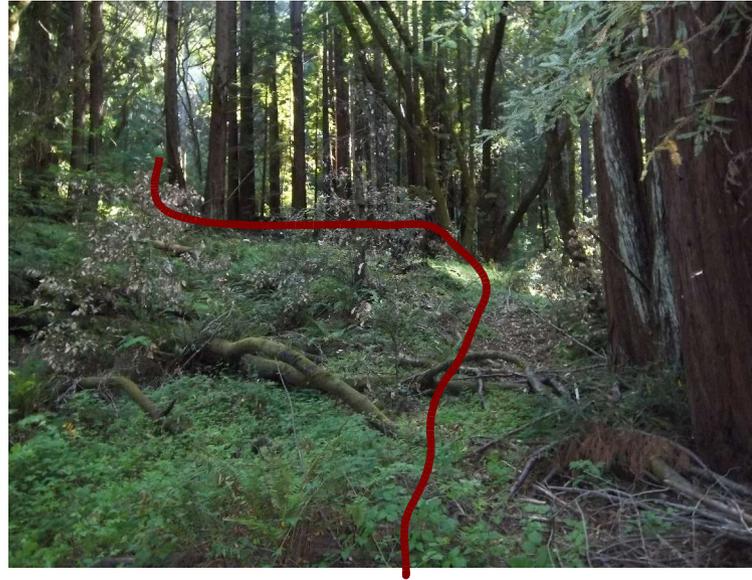
Existing trail looking south

Looking west about 10 feet south of bridge. Trail does a couple of short switchbacks as it climbs away from creeks.

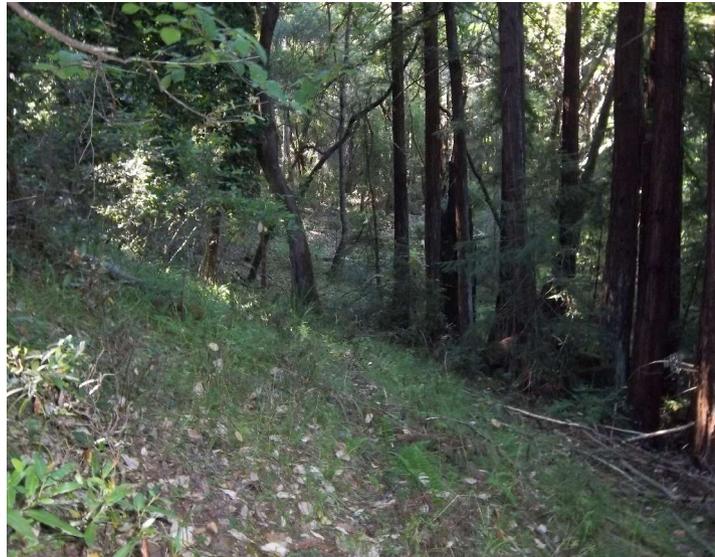
Note
3
ribbons
on one
point

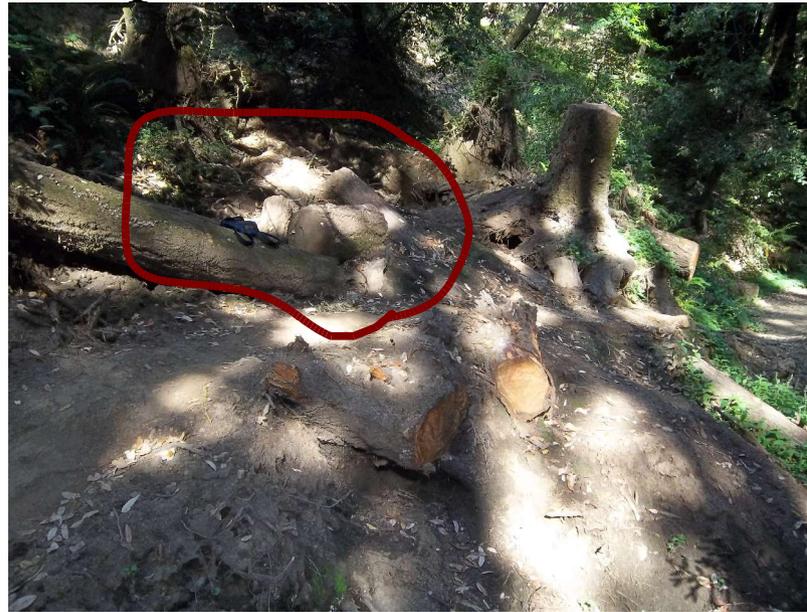
The pit below in lower right is where rider and horse would end up if horse slipped in steep section. Horse would have trees above and stump to left. No place for horse or rider to be safe. Will require large animal rescue to get out and high probability rider will be injured as secondary event .

Once equestrian starts into area there is no turn around location prior to the rounds. If horse will not cross rounds rider is stuck in dangerous location. Simplest repair is to clear area of debris

- Allow re-route to be put into use immediately
 - Removes about 1/3mile of high maintenance trail
 - Is safer for horses and riders
 - Has ability to connect back to Indian and gullies trail
 - Simple route and is just about passable to horses now.
- Secondary option and not preferred
Make passage through slide area safer
 - Clear out debris on west side to give turn around or escape area for horses
 - Remove more of tree and stump jutting into trail
 - Clear pit so not a secondary injury site (this is difficult) Rock cage might give short term solution to shore up bank.

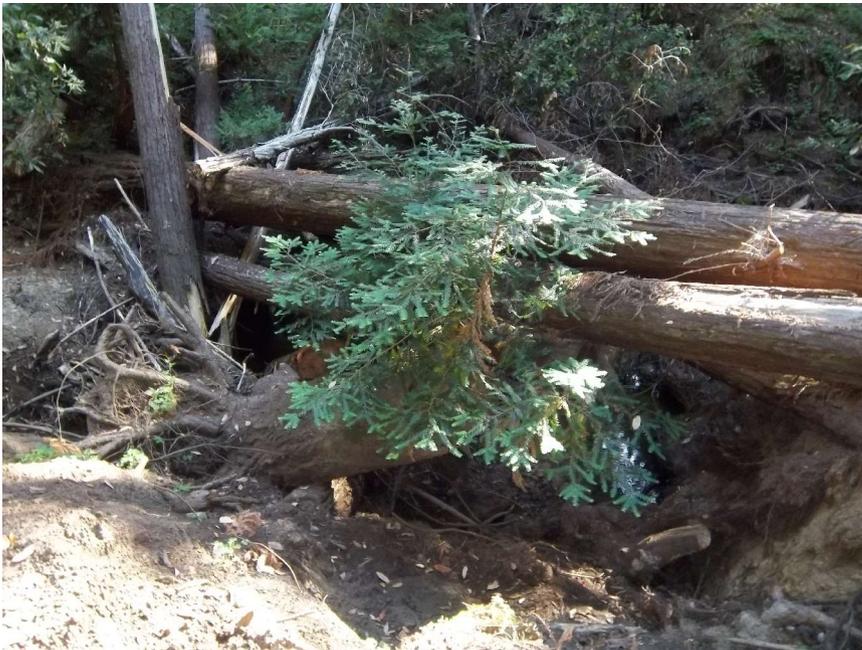
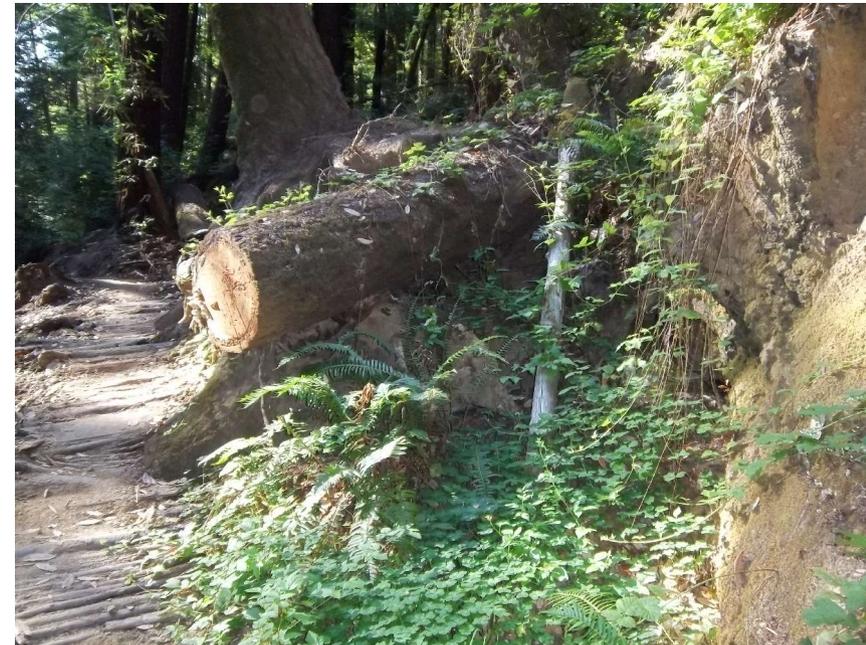
Tree limb is on another stump. Both making widening of path difficult
